Applies To:

Sport 3's - Reassembly after shipping in "breakdown" length, or any time rear leading edges are removed. Tuning by adjusting sail tension.

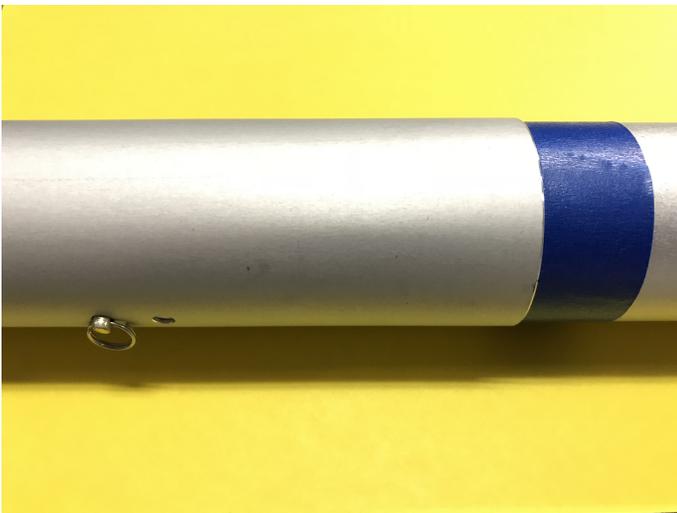
Right Leading edge, assembled in stock tension position.

During assembly of the airframe, blue tape, 15/16" wide, is applied to the rear leading edge in alignment with the rear end of the front leading edge over sleeve. When re-assembling a glider that was broken down for shipping, simply slide the rear leading edge into the front until the forward edge of the tape aligns with the end of the over sleeve. At this point, one of the holes in the rear leading edge should align with one of the holes in the front leading edge. Install the clevis pin, from the outside or forward side of the leading edge, and install the safety ring.

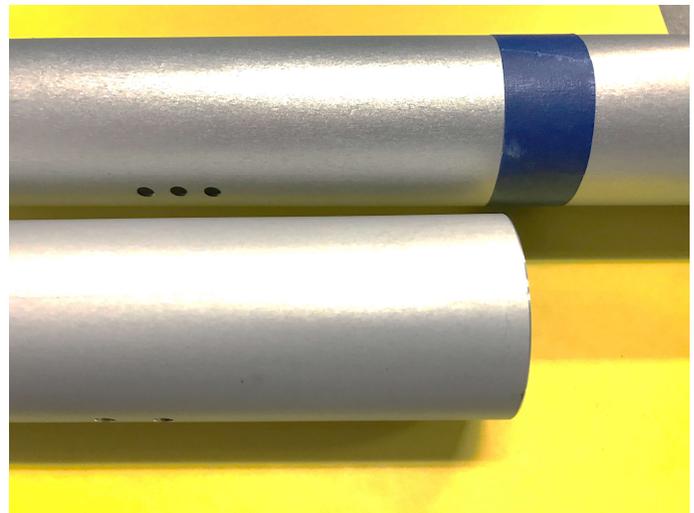
Front and rear leading edges disassembled, showing holes.

If it is necessary to loosen or tighten the sail for tuning purposes, first dismount the sail at the rear of the leading edge by removing the clevis pin there. Remove the tape, then remove the pin at the front leading edge over sleeve, slide the rear leading edge in (to loosen) or out (to tighten) by 3/16 of an inch until the next pair of holes lines up, and re-install the pin and safety. Reapply the tape to mark the new adjustment.

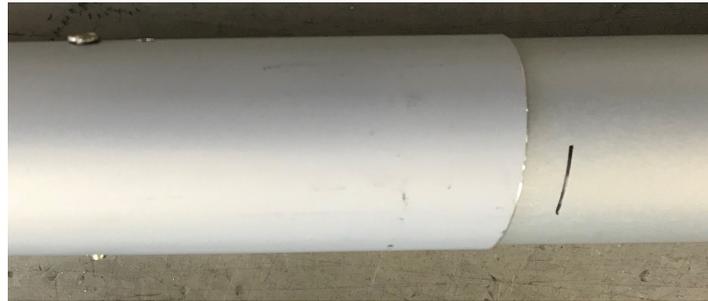
Early Sport 3's did not have the blue tape marking the stock setting. During production, a black permanent marker line is made on the rear leading edge, marking the alignment of the front leading edge over sleeve when the rear leading edge is all the way forward (loosest sail tension adjustment – 3rd one down in the diagram above). In the stock adjustment, this line should be 3/8" behind the rear edge of the front leading edge over sleeve (not lined up with the rear edge of the over sleeve) as shown in the following picture.

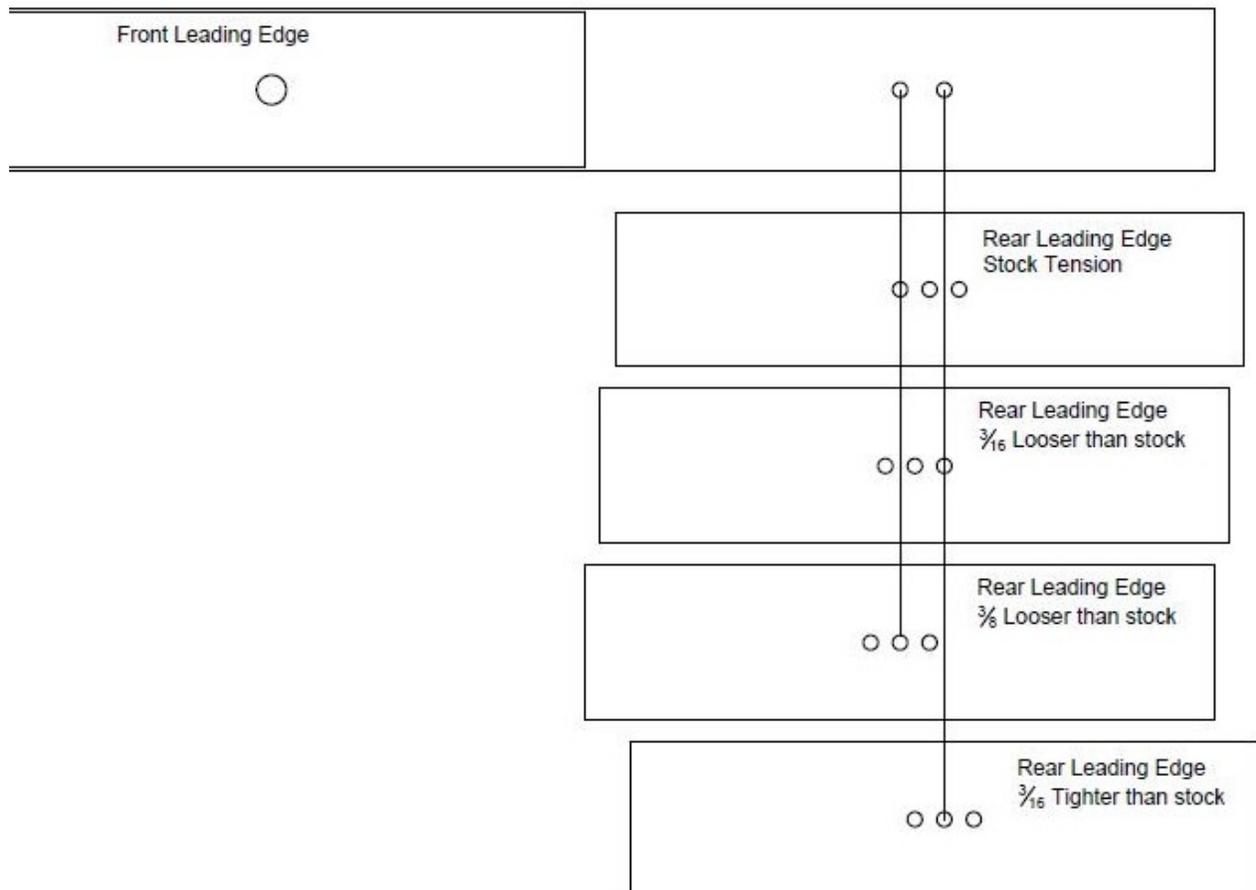
The diagram below shows in detail the four useable alignments if the front and rear leading edges:

- 1) Pin in the forward FLE hole and forward RLE hole – this is the STOCK tension adjustment.
- 2) Pin in the rear FLE hole and rear RLE hole – this adjustment is $\frac{3}{16}$ inch looser than stock
- 3) Pin in the forward FLE hole and middle RLE hole – this adjustment is $\frac{3}{8}$ inch looser than stock
- 4) Pin in the rear FLE hole and middle RLE hole – this adjustment is $\frac{3}{16}$ inch tighter than stock

The setting with the pin in the forward FLE hole and rear RLE hole cannot be obtained because the rear leading edge bottoms out against the rear end of the front leading edge, inside the over sleeve.

The setting with the pin in the rear FLE hole and front RLE hole can be achieved, but this is not a useable setting. This would be $\frac{9}{16}$ " tighter than stock and the sail tension in this configuration would be much too high.)
