### Applies To

U2 – all sizes

# Wills Wing Technical Bulletin

## Rope Maintenance and Inspection – Xbar Ball Center to VG Bock Connection

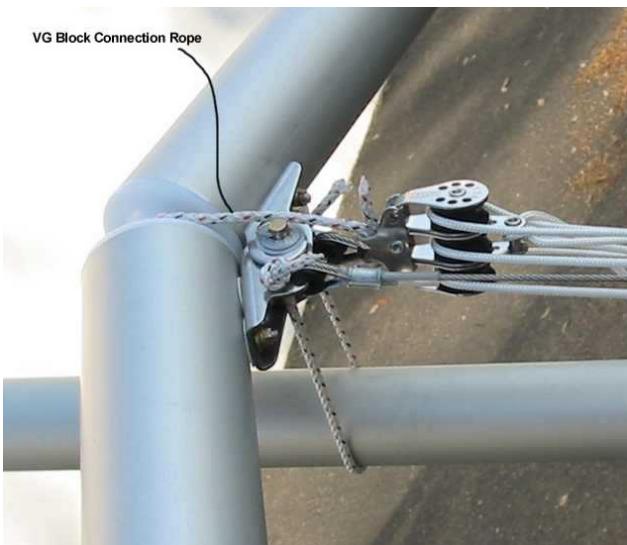
On the U2 and Sport 2 gliders, the forward pulley block for the VG system is anchored to the xbar center ball by a short loop of rope.

On gliders assembled prior to June of 2005, the rope used was a single loop of 4mm Super Pre-Stretch, (as shown in the photo above) and it was secured with a square knot (as illustrated below).

We recommend an upgrade of this rope connection on all gliders to the current configuration, detailed below. Regular subsequent inspection and periodic replacement of this rope is also necessary to preclude the possibility of an in-flight failure of this rope connection. When the VG is set to other than the full loose adjustment, this rope is under significant tension, and this tension increases as additional maneuvering loads or gust loads are placed on the glider in flight. If this rope were to fail in flight, the crossbar would move forward unrestricted, until the sweep wire became tight – thus placing a shock load on the sweep wire. Although we have received no reports of in-flight failures of the sweep wire on any Wills Wing glider, we have seen anecdotal reports of sweep wire failure under shock load on other gliders, indicating that such a failure is possible.

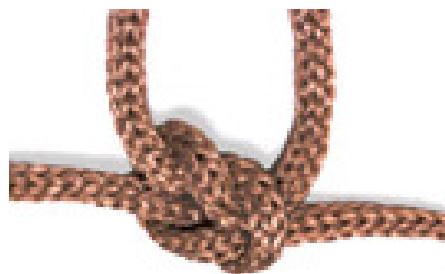
A square knot is not a considered a permanent knot, and thus is not an appropriate knot for this application. Subsequent to June of 2005, the knot was changed to a fisherman's knot, which is the knot that should be used in this application.

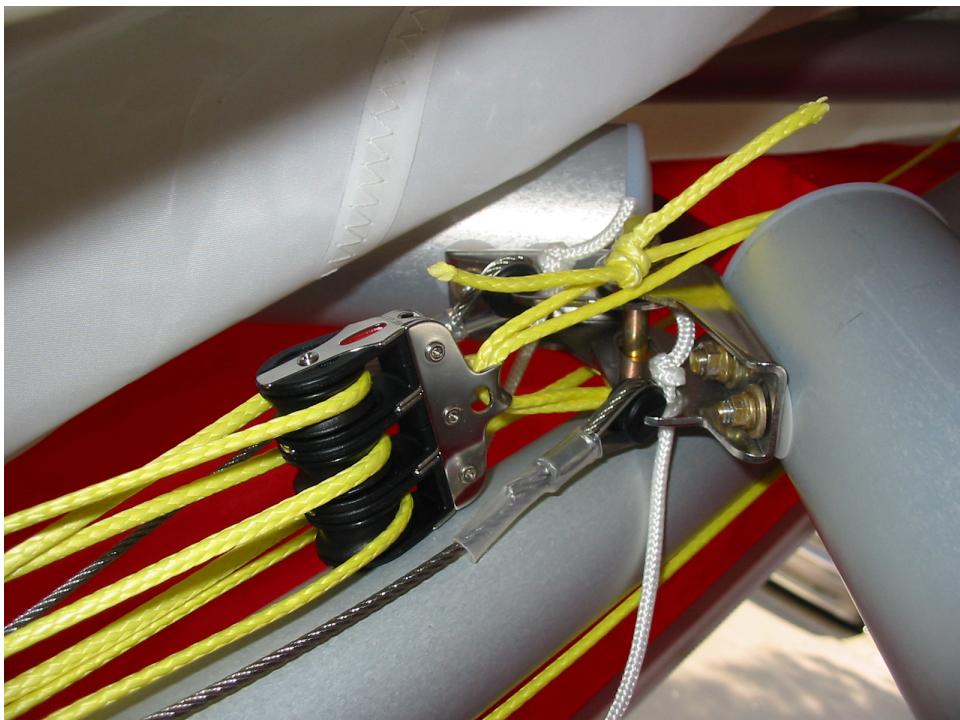
We are currently using 30J-3012 CORD - 3MM OC3-3Y YELLOW in this application. This material is more resistant to wear than is the 4mm Super Pre-Stretch, however it also has a slicker surface. Gliders on which this material was used that were assembled prior to May 15, 2007 used a single loop of this rope to make this connection, secured with a fisherman's knot. Testing of this type of loop has shown that under high loads, the knots may gradually slip. As a result, we are now using a double loop of this material, as shown.

We are recommending that all Sport 2's and U2's be upgraded to the double loop of 3MM OC3-3Y YELLOW cord, and that all such gliders, even subsequent to this upgrade, be inspected on a regular basis for any sign of wear on the rope and to insure the integrity of the securing knots.

To replace the rope, simply cut off the old rope and install the new one. Pass one end of the rope down through the bracket on the pulley block, then upwards through the hole in the xbar center ball, down again through the bracket, and then up through the ball a second time, following the routing as shown above, and bringing the two free ends of the rope together above the keel center between the ball and the pulley block.

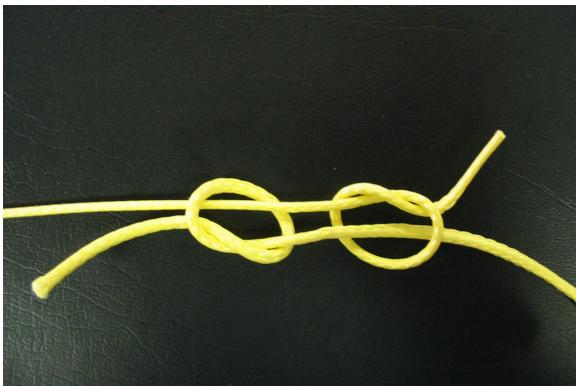
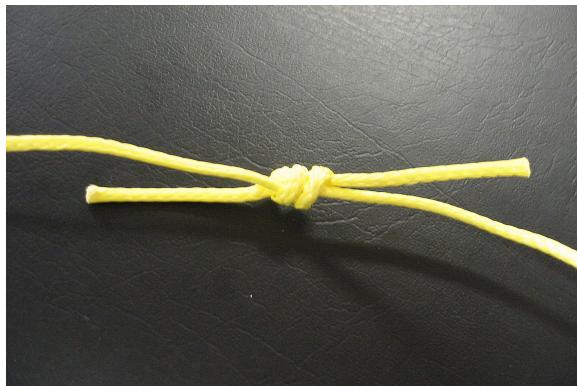
Tie the fisherman's knot as illustrated below, and then gradually adjust the length of the double loop to that shown in the photo above as you snug up the individual overhand knots and draw them together.

Note that the final adjusted length of the loop is important - if the rope loop is too long, the range of the VG system will be reduced. If the loop is too short, it will come under excessive tension when the glider is folded up, as the xbar center ball moves farther away from the back side of the hinge bracket assembly. The length of the loop should be such that with the wings spread about half way, the pulley block can be pulled about  $\frac{3}{4}$  of an inch (20mm) away from the back edge of the hinge brackets. Check the rope again with the wings completely folded – it should be between snug and just slack, but not tight, and no more than just slack.

Once the adjustment of the length of the loop has been finalized, pull the individual overhand knots as tight as possible by pulling on the free end of the rope while restraining the associated knot, and then pull the two overhand knots together as tight as possible by pulling on the working ends of the rope just outside the overhand knots. When the knot is as tight and secure as you can make it, trim the free ends to no shorter than two inches, and heat-seal the ends.
