## Applies To

All Models with Ball / Socket Xbar Center Junctions – Falcons, XCs, Ultra Sports, Eagles, Condors, U2s, Sport 2s

## Introduction

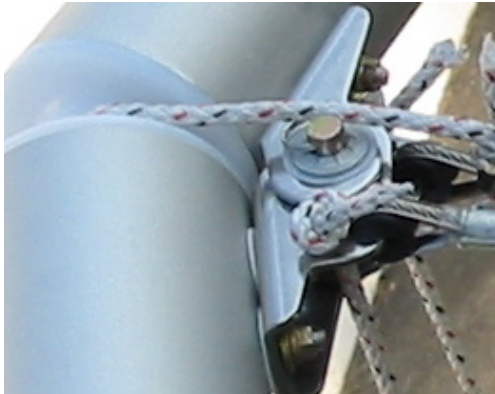
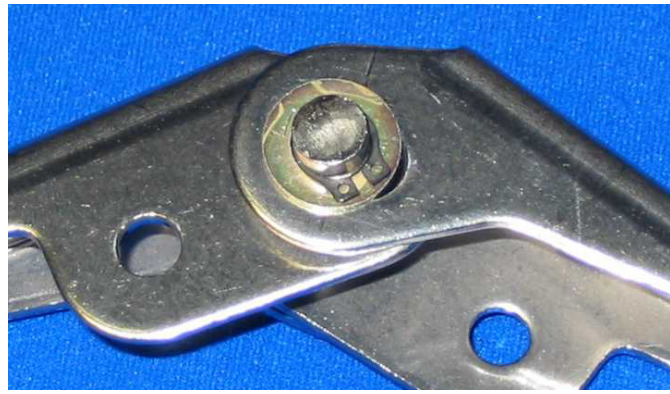
Originally, the center hinge fastener in this assembly was an NAS 623 517 Bolt and 5/16 Clinch Nut. In the spring of 2002, we switched to a combination of a 4C-37 Clevis Pin, a 5/16" Pushnut, and a safety ring for the center hinge pin in this assembly (pictured above, on left). In late 2004, we switched this assembly again to a grooved 5/16" clevis pin and a snap ring retainer (pictured above, on right.)

We switched to the snap ring and grooved pin originally because after using the push nut and safety ring assembly successfully for more than two years, we began to see cases where the push nut was not adequately or securely engaging the clevis pin. Since switching to the snap ring, we have found that the snap ring can be dislodged from the pin in apparently normal use, allowing the pin to fall out and disconnecting the hinge brackets (and thereby the crossbar halves) from one another. Although this pin connection is not a load bearing assembly in flight, it does serve to guide the ball on one crossbar into proper engagement with the socket on the other crossbar during set-up, and maintain that alignment at any time that the crossbars are not loaded. We have changed our assembly procedures to again incorporate a bolt and locknut in this assembly, and we are recommending that all gliders manufactured with the grooved pin and snap ring assembly, or with the push nut and safety ring assembly, be upgraded to the bolt and nut assembly. We have also replaced the nylon washers between the hinge brackets on the hinge bolt with brass washers, and recommend that these washers be replaced when the pin is replaced by the bolt and nut.
