## Applies To

T2 models using the Sweep Wire Button Lock as shown

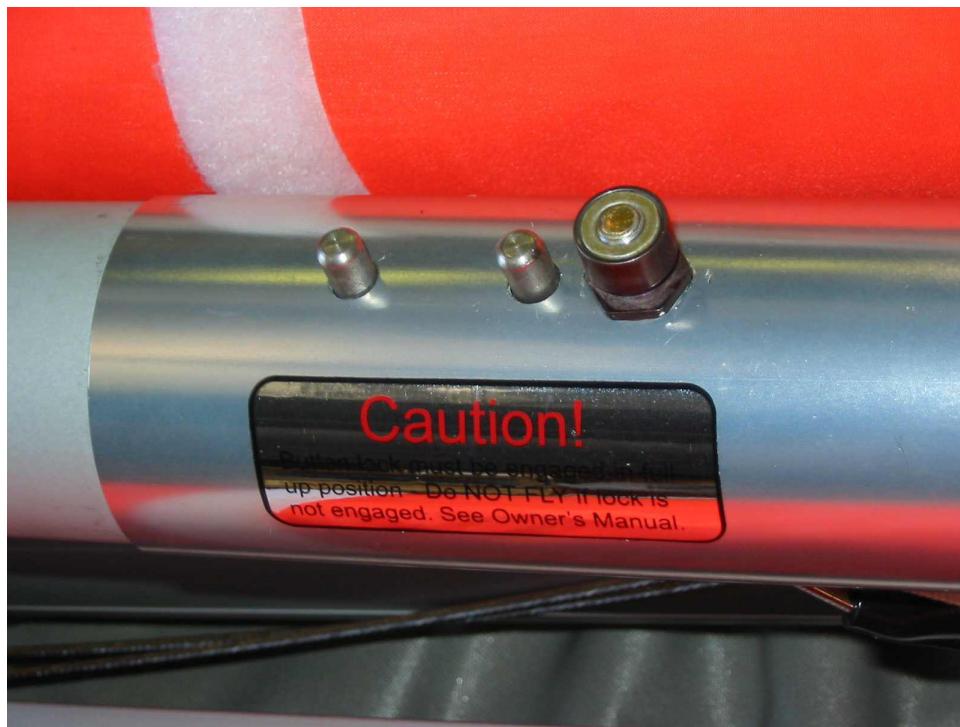
All T2's should have a warning label installed adjacent to the sweep wire keyhole collar on the rear keel, as per the illustration below.

On the T2, it is ABSOLUTELY NECESSARY that the button lock safety be fully functioning and fully engaged whenever the sweep wire is attached – it is a NO FLY condition if the button lock becomes stuck in the down position such that it does not properly prevent the sweep wire from becoming detached from the collar. The reason that this is so critically important on the T2 is that if the VG is pulled on and then released on the ground, the crossbar will likely not fully return to its full forward position, leaving the sweep wire slack, and allowing the sweep wire tang to disengage from the keyhole collar if the safety is not engaged. Never install the keyhole tang onto the keyhole bolt without making absolutely sure that the tang is fully engaged on the narrow neck of the bolt, and pulled forward into the fully locked position with the safety button in the full up position. An in-flight disengagement of this attachment will cause a complete loss of structural support of the glider and a total loss of control. Never attach the pull string to the collar, even temporarily. (Note, if the button should become stuck in the down position, it can usually be released and made to pop up by lifting on the keel tube just forward of the keyhole collar bolt, and thus taking any upward load off of the rear stinger.)

T2 Sweep Wire Button Lock Warning Sticker – available on request at no charge.
