16 Z5 Harnesses rigged between 7/3/2014 and 11/10/2014 with Amsteel Gray 1/8" diameter rope.

Service Requirement:

Inspect and service as necessary.

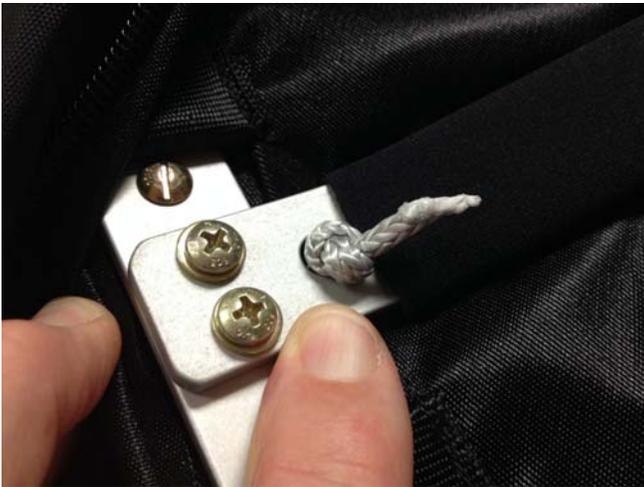
The 4mm accessory cord can be retained in the front spreader bar with a single overhand knot. The Amsteel 1/8 inch rope requires a double overhand knot, backed up by a washer. A number of Z5's were rigged with the Amsteel 1/8 inch rope with a single overhand knot, with no washer, and these need to be corrected. Without correction, it is possible for the knot to slip through the hole in the spreader bar.

The photo on the left shows the INCORRECT configuration. The photo on the right is the correct configuration.

(The photos show the right side of the spreader bar – on the left side there are two lines attached at this point. The location shown is accessed by unzipping the storage area zipper inside the harness.)

10U-1130 WASHER STEEL AN960-10 (Qty 3)
